PROPOSALS FOR TECHNICAL DEVELOPMENT OF HAMMER CRUSHERS APPLIED IN BIOGAS PLANTS

Abstract: *Feeding of the reactors becomes one of the most important part in managing a Biogas plant, because it is a critical factor for the stable biogas production.*

This article overviews all the experiences we could gain from a research work performed in a biogas plant, aiming the improvement of the applied technology, focusing on the solid input material crushing process.

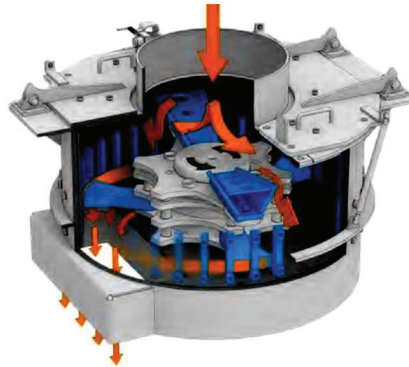
Fig. 1. The BHS Biogrinder RBG 08 parts

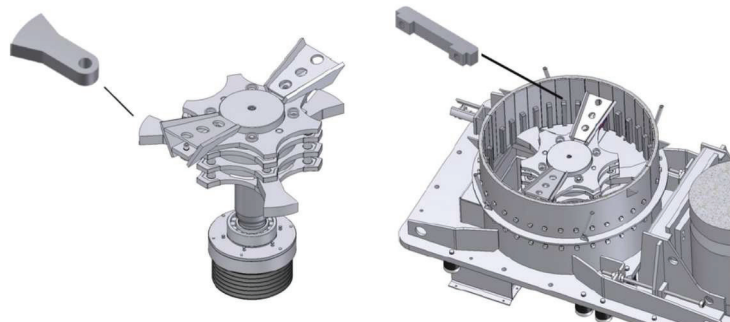
In the investigated biogas technology the biomass grinding is made by turning hammers. One machine is able to get 12 hammers. The material flow is supported by standing part; it is working like a standing knife. The turning parts are demonstrated at next figures.

Fig 2. The BHS Biogrinder RBG 08 machine turning and fix parts

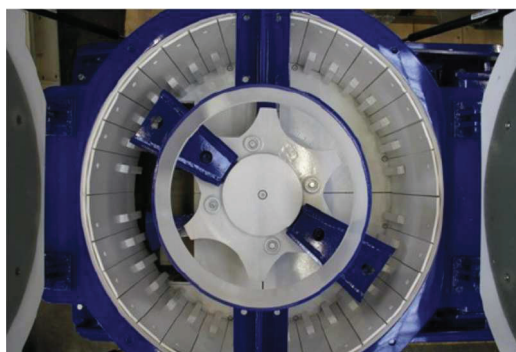
Fig 3. The turning and fix parts view from top

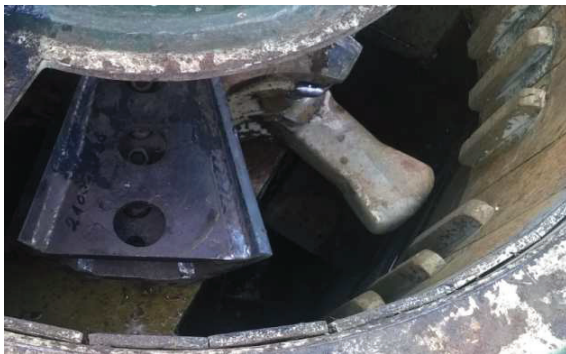
Figure 4 and 5 show the difference between the original and used hammer.

Fig 4. Distance between fix part and hammer, original (operational photo)

This effect is typical on animal farms. The tested plant is a real source of danger, because the sand rate of the manure is high. Because of the wearing fix part and moving hammer have bigger distance, the shredding efficiency get worse.

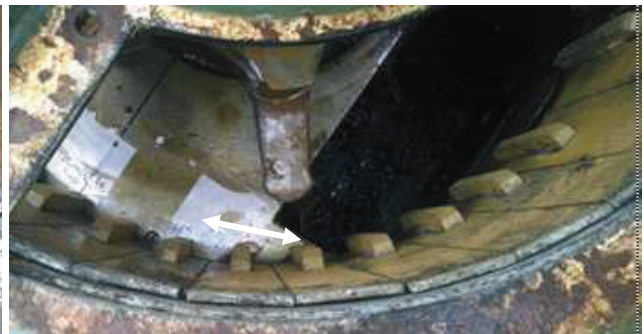
Fig 5. Distance with used hammer (operational photo)

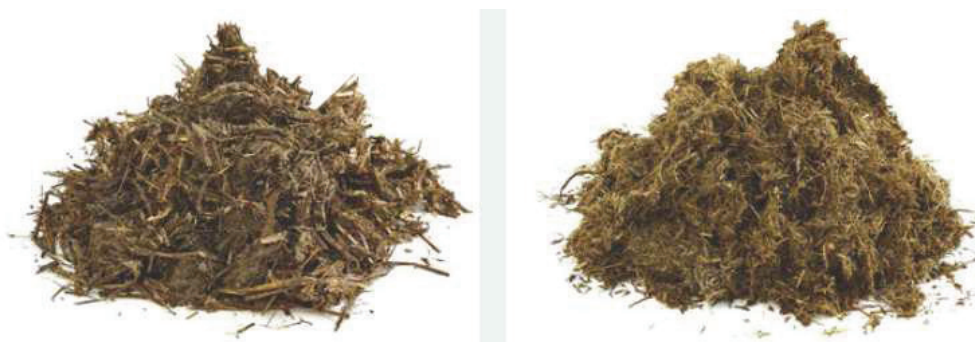
Based on institute (Institut für Landtechnik und Tierhaltung, Weihenstephan, Freising) measurement we mentioned that the structure of manure from straw did not change using hammered shredding. This type of machine is not applicable for this type of materials.

Fig 6. Manure from straw, before and after crushing

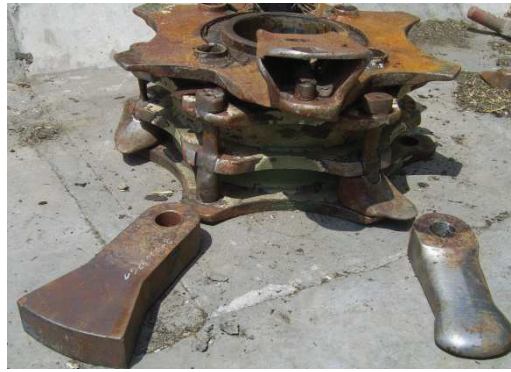
Fig 7. New and worn hammer

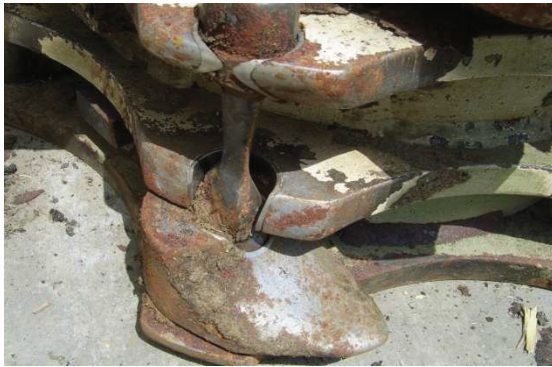
Fig. 8 and 9 shows the implemented and the stand-alone hammer. The form changing is too big for normal usage.

Fig 8. Used hammer

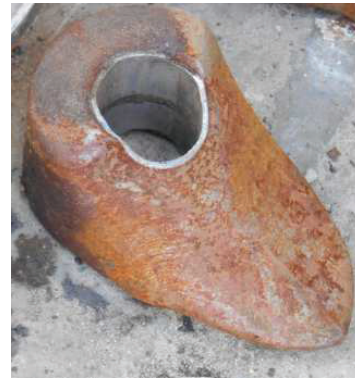
Fig 9. Unmounted used hammer

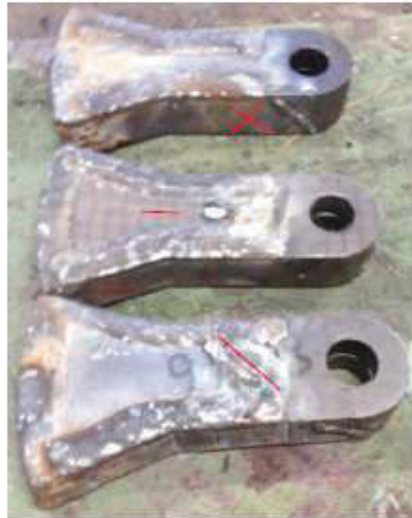
- 1) **The (-) signed hammer**, the suture was parallel with the axle.
- 2) **The (/) signed hammer** the suture was at 45° by the axle, at the same distance
- 3) **The (X) signed hammer** the suture was at 45° by the axle but the opposite direction as / signed hammers. Sutures are at the same distance.

Fig 10. Hard metal welded hammers

Sign	Standard	Chemical (%)	Current
502	DIN 8555: E 10-GF-60 GR	C: 5,50 Mn: 1,50 Cr: 40,0 Other: 2	= +160 A

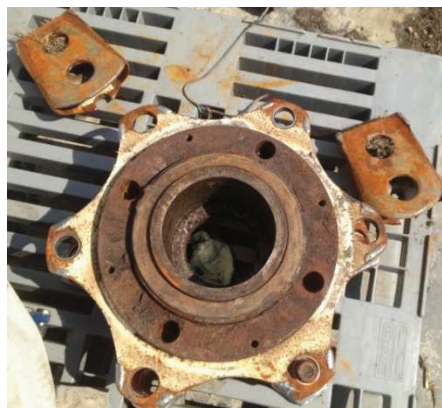
The shredder was used at normal working conditions in the investigated biogas plant. After 600 working hours the wearing was estimated so extreme comparing normal conditions. At the first investigating phase the hammers were checked by a simple visual survey. We diagnosed there were no dangerous anomaly (broken parts, deformation, other structural injury).

Fig 11. After 600 working hours, with hard metal welding

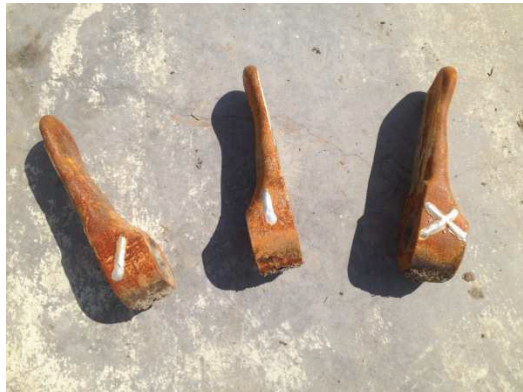
Next figures show the worn hammers. As the pictures show there is no injury on the hammers.

Fig 12. Hammers, side view

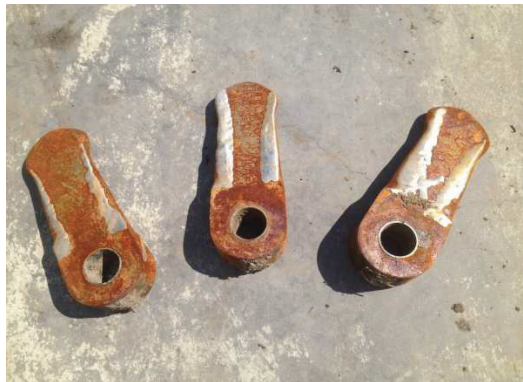
Fig 13. Hammers, top view

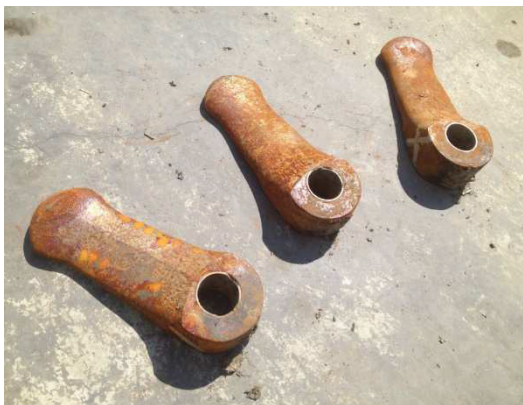
Fig 14. Hammers, bottom view

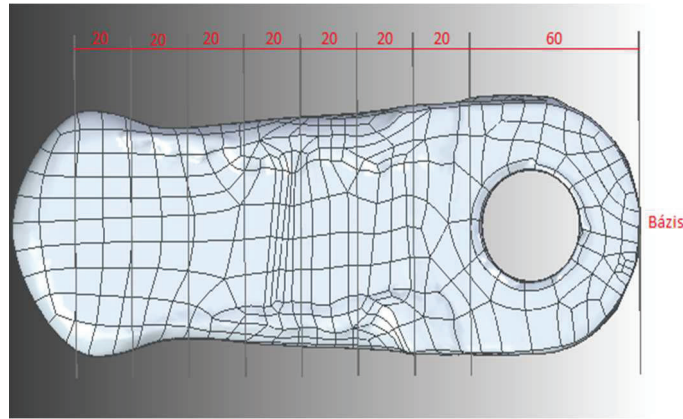
For the further step of the scientific investigation we applied 3D scanning technology to measure the wearing size. The 3D scanner is a ZScanner 700 machine.

- define joints, surface net
- elementary body unit calculation
- surface units summary

Fig 15. Scanned worn hammer

Table 1 shows the results for (/) signed hammer. This has the minimal size changing: 83,5% of the original size remained. The most intensive worn was realized on the hammer signed (-).
